NATIONAL AERONAUTICS AND SPACE ADMINISTRATION

APOLLO 9 MISSION REPORT

MANNED SPACECRAFT CENTER

MAY 1969

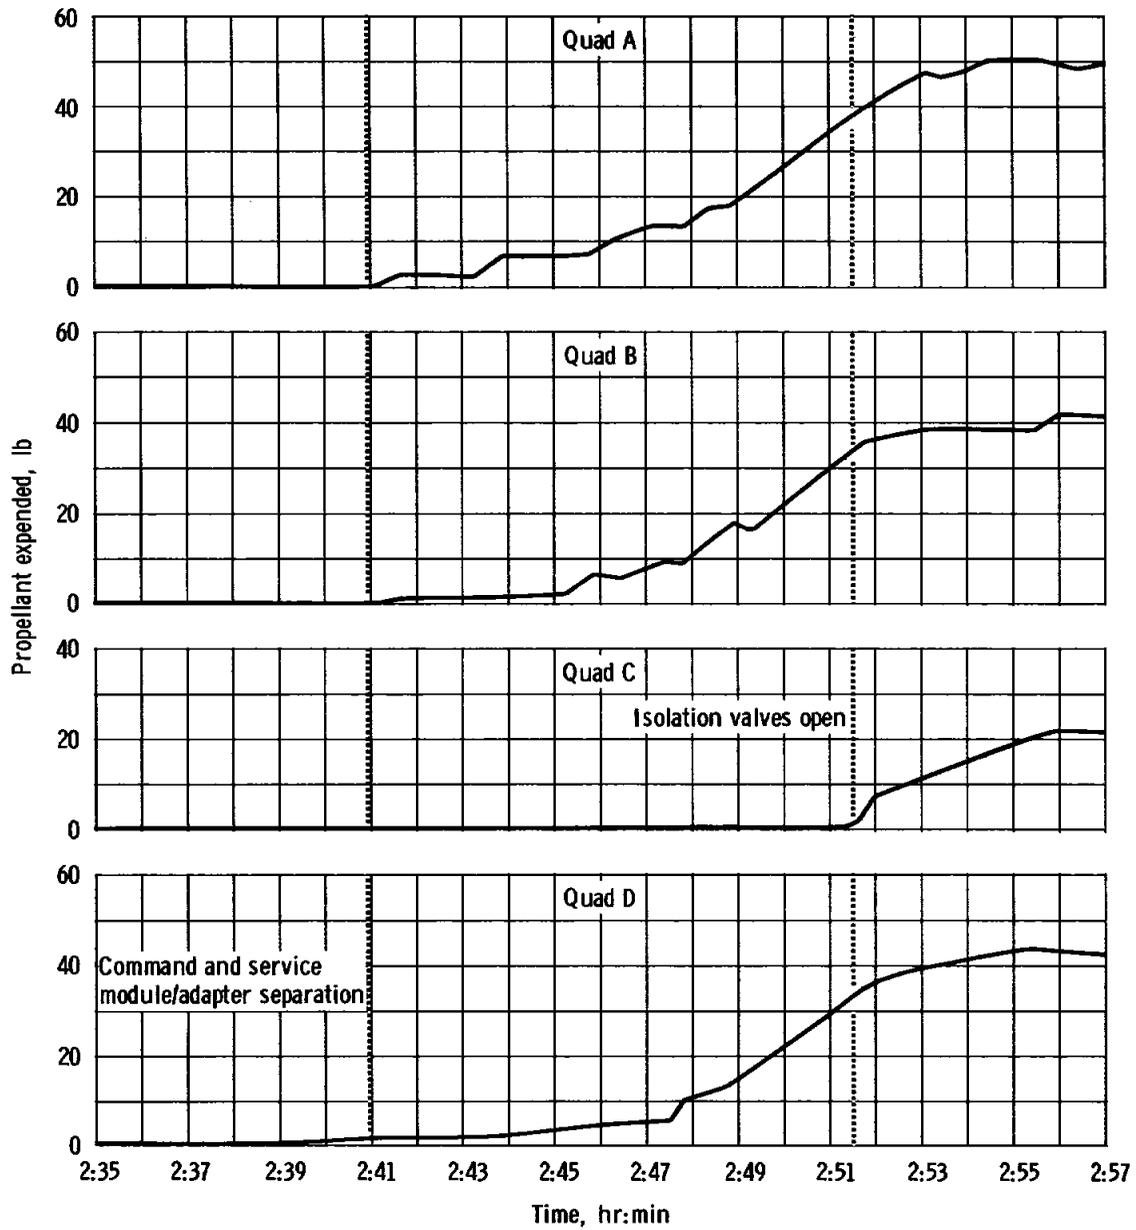
Figure 17-2. - Propellant expended showing inactivity of quad C.

Propellant usage data (fig. 17-2) showed that all four quad C valves were closed and that quad D was performing normally before the crew reopened the propellant isolation valves. Propellant may be supplied from either the primary or secondary tanks, and only the valve indicator for the secondary tank was in the "barber pole" position for quad D. Closure of only one of the secondary valves is sufficient to cause the indication (fig. 17-1).

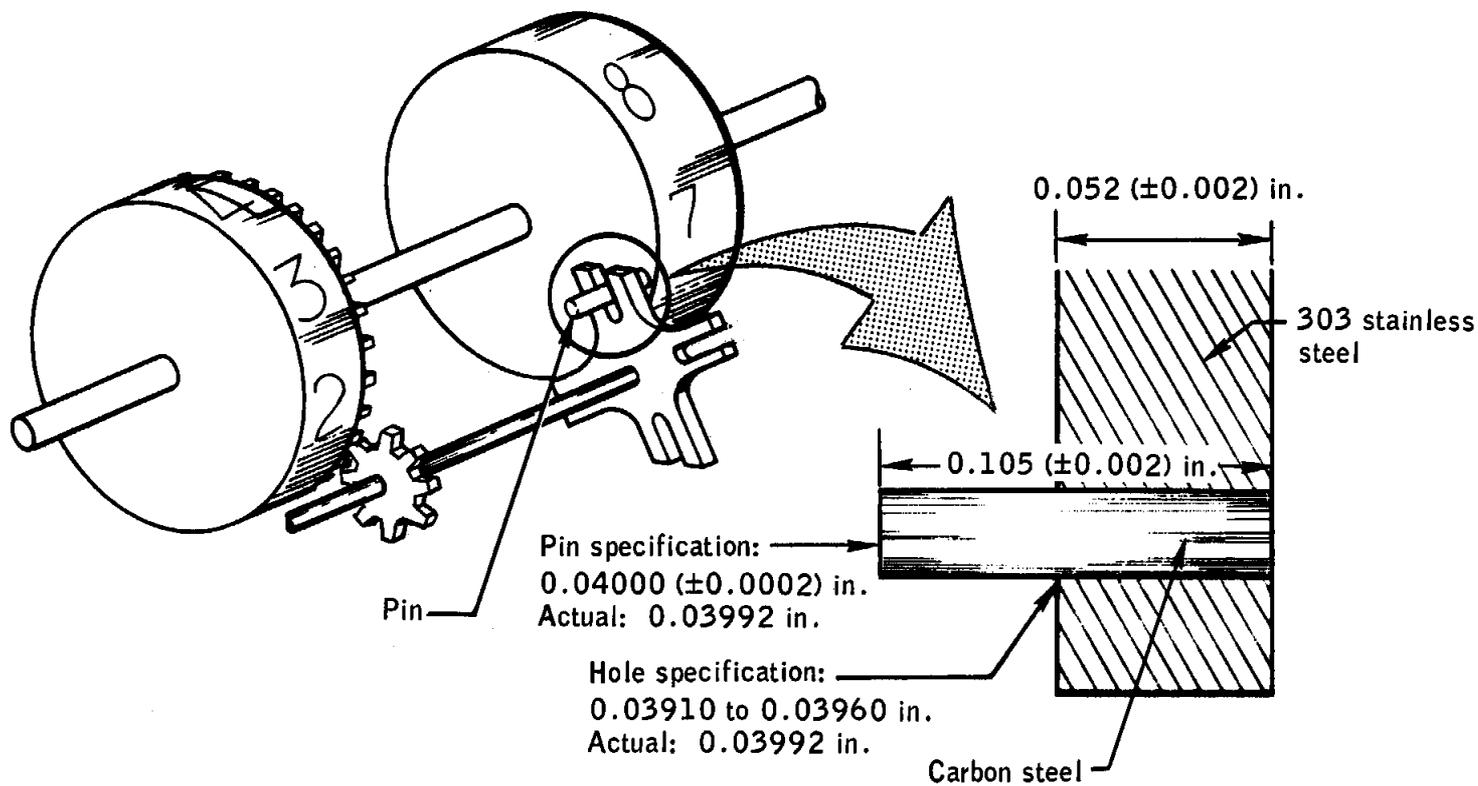
Figure 17-4.- Scanning telescope counter.

The counter malfunction was caused by the pin on the "tenths" drum dropping out (fig. 17-4) and eventually jamming the gear. One revolution of the counter shaft results in the pin engaging a geneva gear which is meshed to the "units" drum of the counter. If the pin is missing, the "tenths" drum will rotate but, the "units" drum will not be engaged through the geneva mechanism, resulting in no movement of the degree indicators of the counter. The intermittent sticking of the shaft was caused by the loose pin from the counter lodging between the split anti-backlash gear on the shaft resolver. Repeated operation of the manual adjust screw with the universal tool eventually wedged the pin between the anti-backlash gears, providing proper mesh of the gear train; this, in turn, freed the telescope shaft and enabled proper freedom of motion. Detailed tolerance measurements of the failed unit show that all parts conformed to the drawings and specifications with the exception of the hole on the "tenths" drive hub. The hole, which should have retained the pin, was out of tolerance. Figure 17-4 shows the pin/hole interface specification dimensions for this assembly. The hole dimension of the failed part was +0.00032-inch oversize in diameter, resulting in a hole diameter of 0.03992 inch. The pin diameter was measured to be 0.03992 inch. The specification requires an interference fit of 0.0002 to 0.00011 inch. Dynamic load analysis of the counter and a tolerance study of the pin/hole interface indicates that the design is adequate. The failure was the result of an out-of-tolerance hole on the drive hub of the "tenths" drum. Repeated impact by the geneva mechanism resulted in the pin slipping from the hole sufficiently to come into contact with the pinion gear on the counter shaft. Impact by the pin on the pinion gear resulted in the pin dislodging from the drive hub.

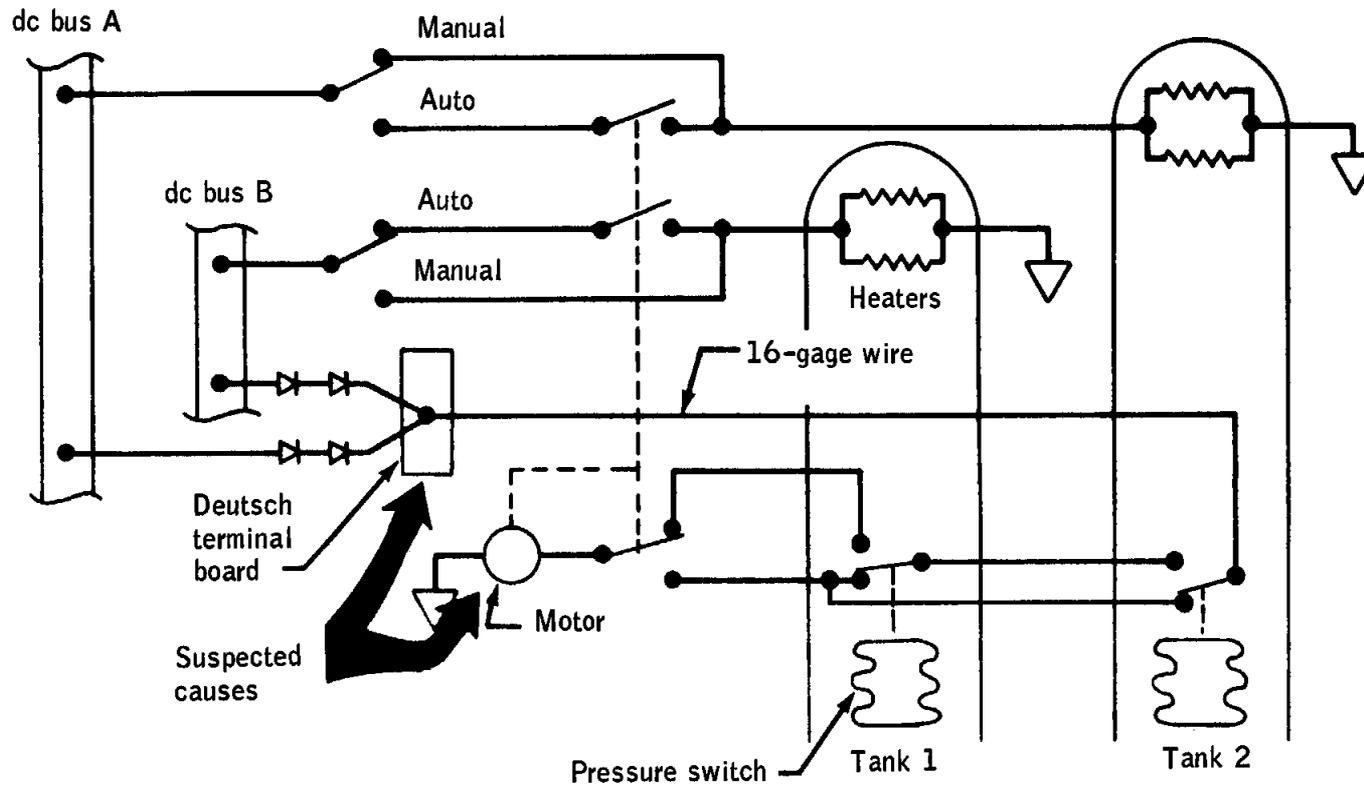
Figure 17-5.- Hydrogen tank pressure control.

During the flight, the automatic pressure control system in the hydrogen tanks failed. The logic of the control system (fig. 17-5) is such that the pressure switches in both tanks must close in order for the heaters to be activated; however, opening of only one pressure switch will deactivate the heaters. The first indication of failure was noted at 93 hours, shortly after the initial undocking, when the heaters were not automatically activated (fig. 17-6). At approximately the time of the final lunar module undocking, all hydrogen tank heaters came on and pressurized the tanks to about 270 psia, which required that the heaters be turned off manually.

Since the first failure (failure to turn on) would have required one pressure switch to fail open and the second failure (failure to turn off) would have required that both pressure switches fail closed, the switches can be ruled out. The most probable cause for the failures was an intermittent open-circuit condition in the motor control circuit (including the power line, ground, and the terminal board for 16-gage pins) resulting from the undocking shock (see fig. 17-5). Sixteen-gage terminal boards have been the source of intermittent contact in other circuits during ground tests.

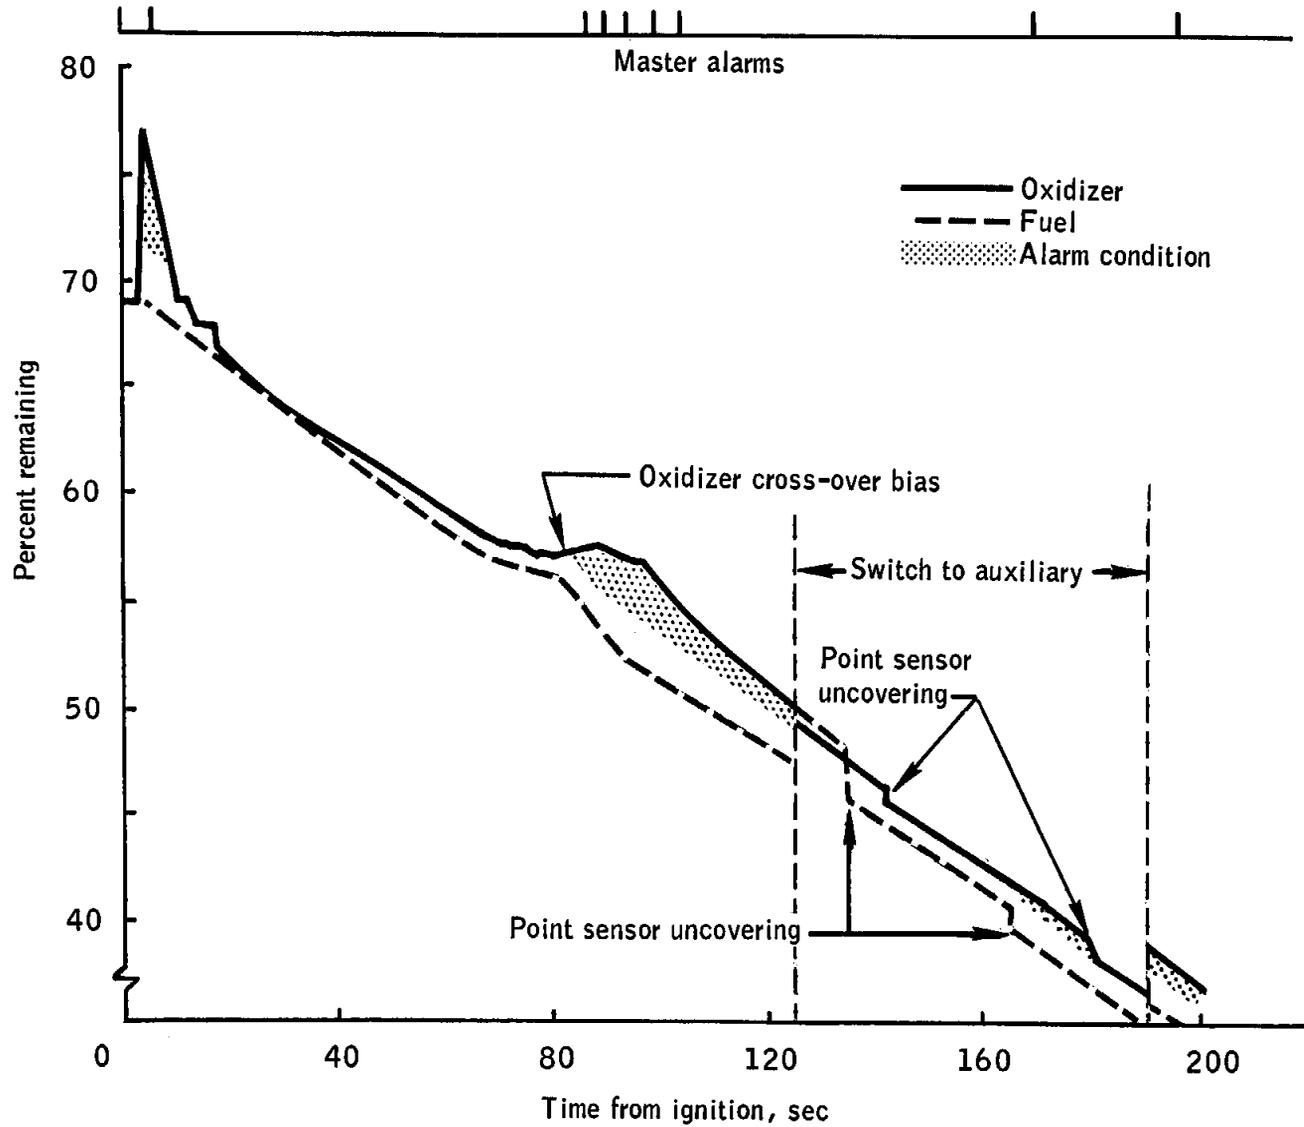
Figure 17-7.- Service propulsion system propellant quantities.

During the third firing of the service propulsion engine, there were eight master alarms from the propellant utilization and gaging system indicating an excessive propellant unbalance (fig. 17-7).

All the master alarms are explainable. The first alarm was caused by propellant level in the capacitive measuring tube not reaching the settled level as soon as expected after start-up. The next five alarms, shown in figure 17-7, resulted from an electrical zero bias in the oxidizer measuring circuit after storage tank depletion. Thus, continuous alarms on the primary gaging system caused the crew to switch to the auxiliary system, which employs point sensors at discrete levels in the tanks.

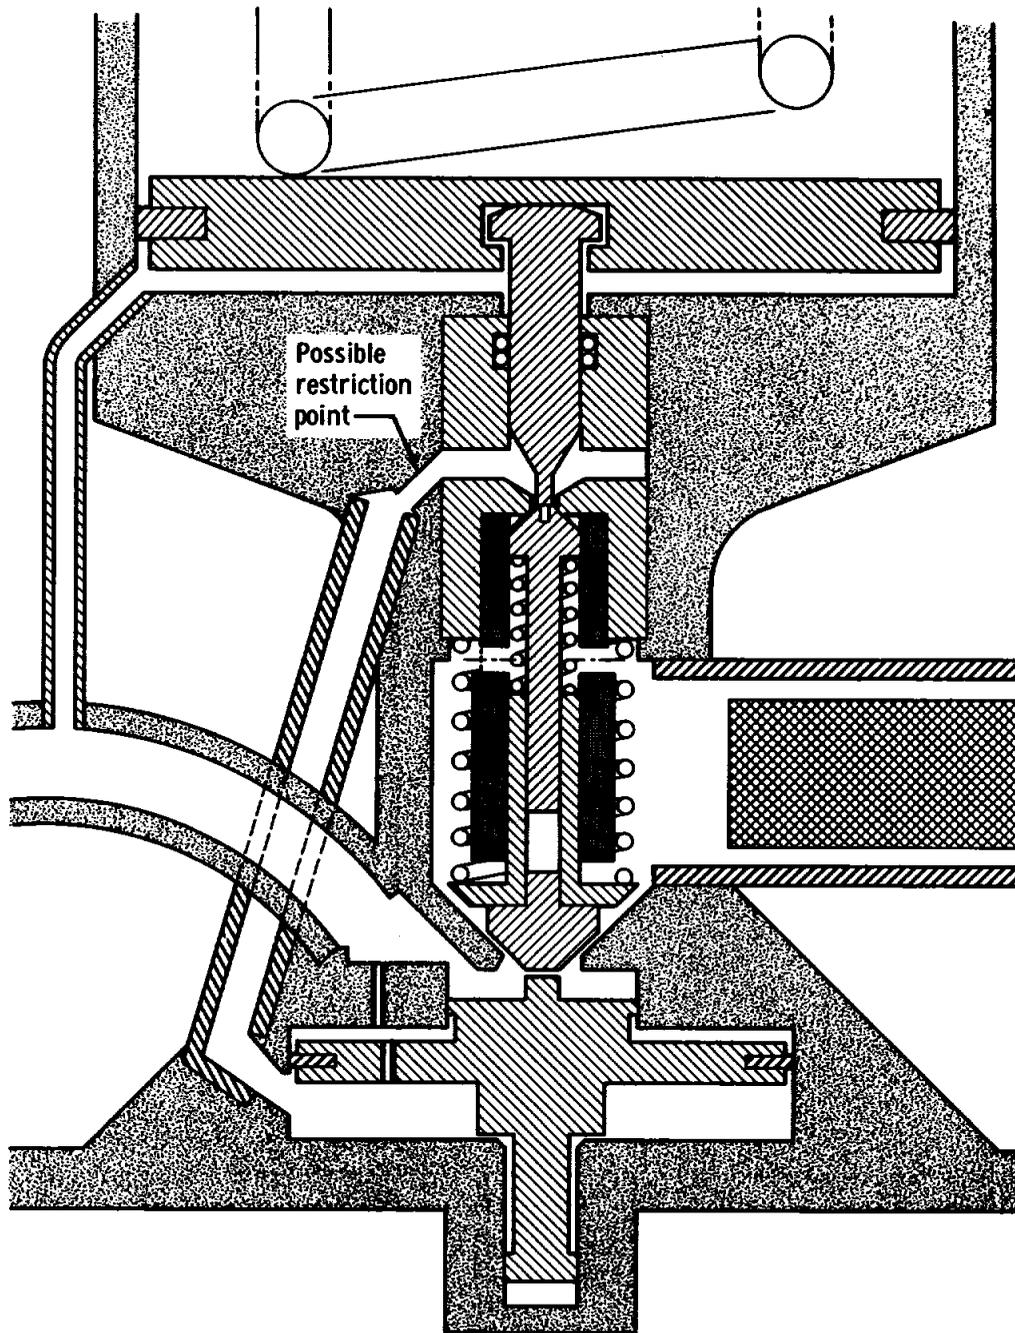
At this time, the most likely conditions which could have caused the indicated malfunction of the class I regulator (see fig. 17-31) was contamination of the regulator. This contamination could have caused a restriction in the feedback line from the pilot poppet to the slave piston. Tests have shown that a regulator band shift can result by reducing the

Figure 17-31. - Cross section of ascent propulsion system regulator.

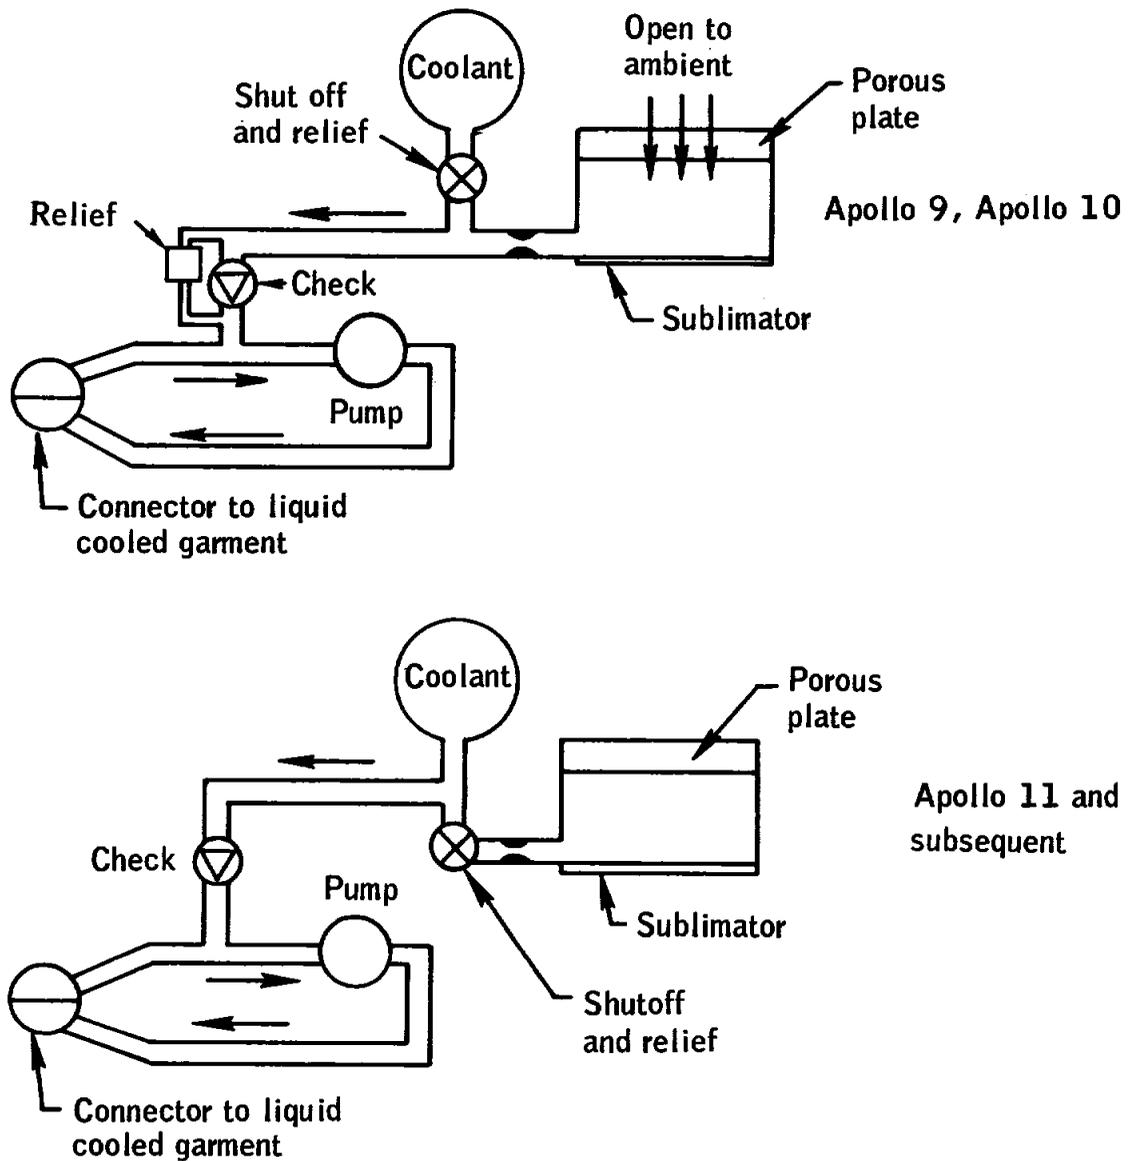
When the Lunar Module Pilot removed his liquid cooled garment after completing the extravehicular activity, he noted many air bubbles entrained in the liquid tubes.

The preflight procedure for charging the portable life support system has been eliminated as a possible source of air inclusion into the system. The air most probably entered the system when the portable life support system was being connected to the liquid cooled garment in the pressurized lunar module cabin. Because of the location of the coolant make-up line for the portable life support system, air is ingested through the sublimator into the coolant loop (fig. 17-32) whenever the total pressure in the liquid cooled garment is less than that in the portable life support system. The amount of air bubbles observed also corresponded roughly to the amount experienced in ground tests whenever the liquid cooled garment had been connected to the portable life support system after having been out of its storage bag, and detached from the life support system for 24 hours. The portable life support system has been redesigned to eliminate this problem for the Apollo 11 hardware (fig. 17-32). This change will relocate the make-up line to the upstream side of the water shutoff and relief valve, and any pressure make-up will be replenished with water instead of gas.

Figure 17-32.- Air in liquid cooled garment at time of connection to portable life support system.

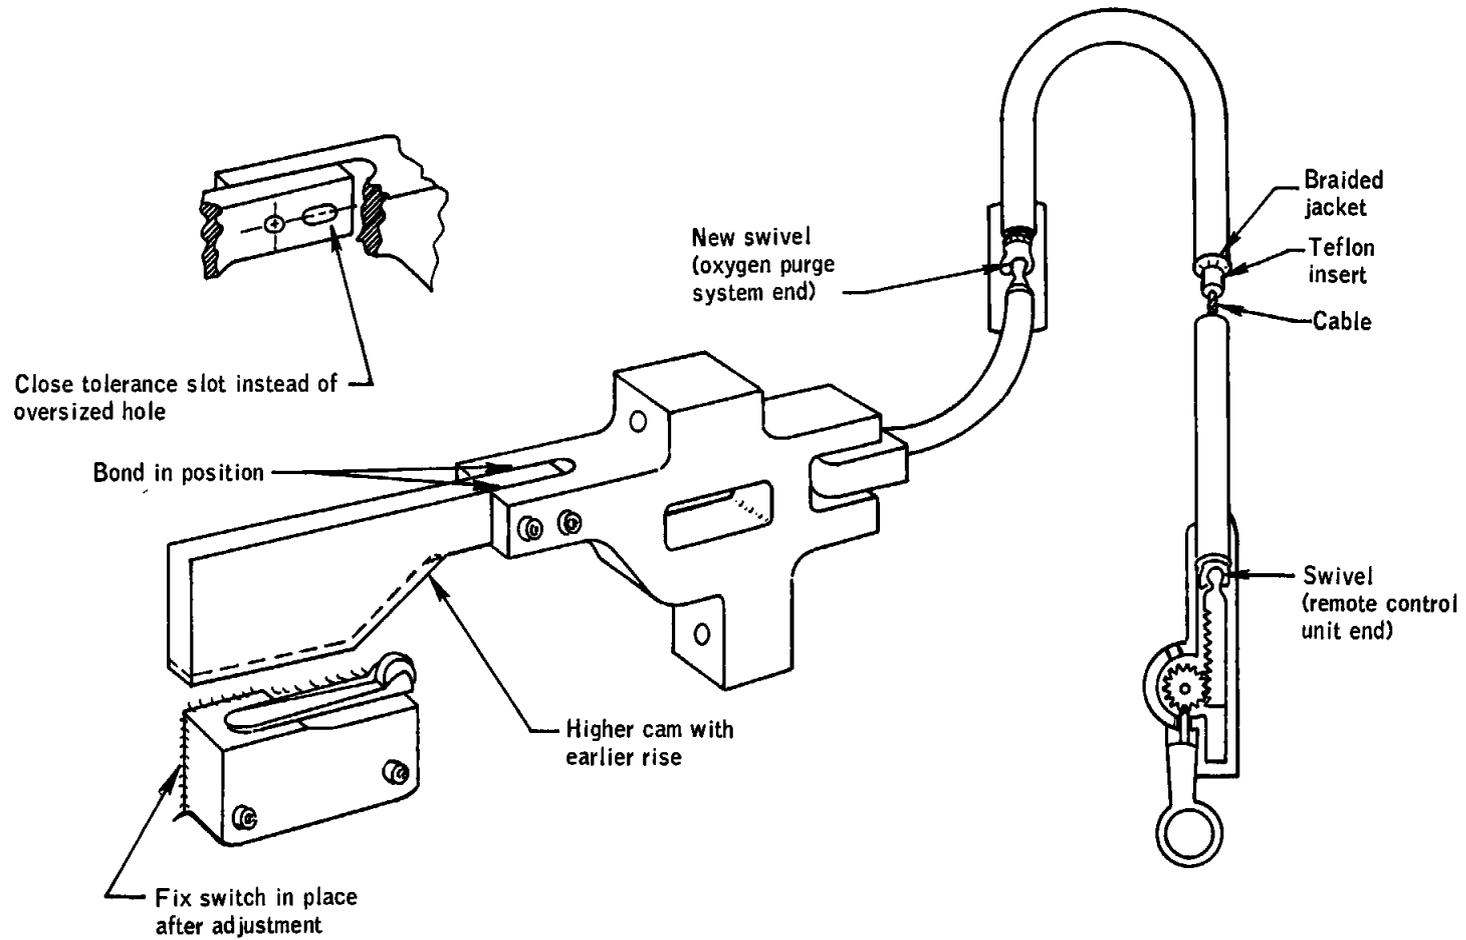
The checkout light on the Commander's oxygen purge system operated erratically during the flight and failed to come on during preparations for rendezvous. An examination of all possible conditions that could have caused the failure indicates that the main power switch actuator

mechanism did not close the switch. The following changes were incorporated into the actuator mechanism (fig. 17-33) for Apollo 10 and subsequent:

Figure 17-33.- Oxygen purge system heater power switch actuator mechanism changes for Apollo 10.

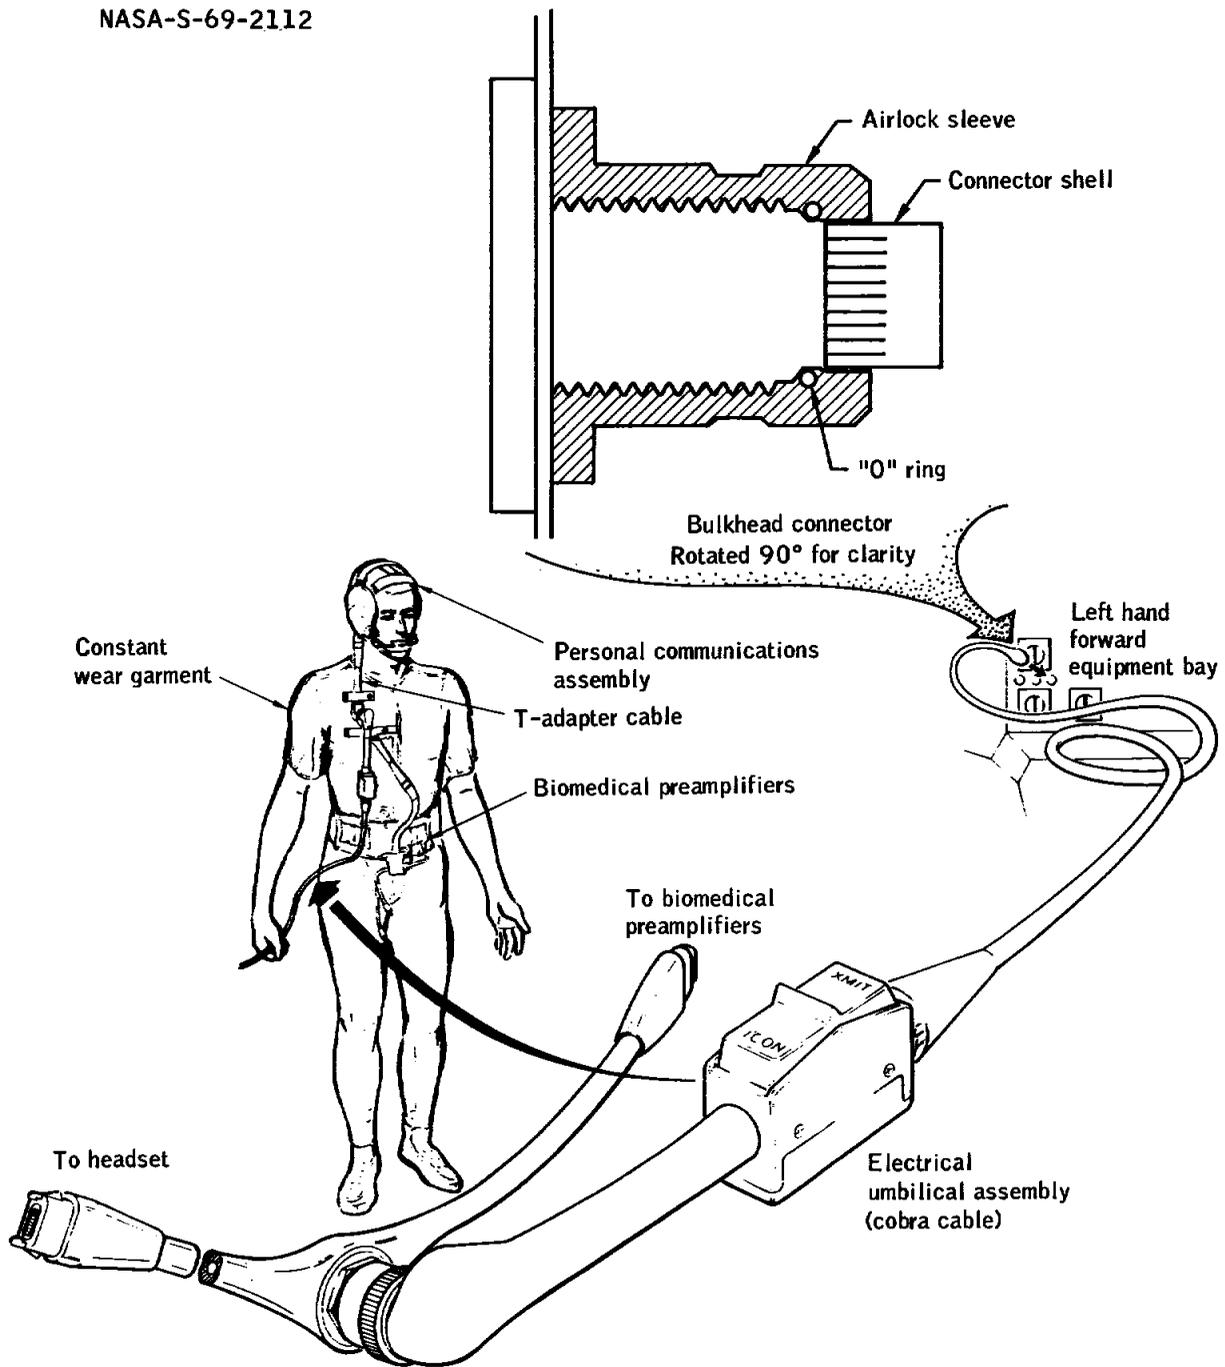
The airlock sleeves on the T-adapters were loose (see fig. 17-34) during mating and demating of the connectors for the postflight tests. Subsequent checks of the spacecraft showed a loose airlock sleeve on the bulkhead connector that mates with the commander's umbilical. Considering the worst case connector insert, pins, and airlock sleeve tolerances, an airlock sleeve loosened by one turn could cause loss of communications. During previous ground tests, loss of communications has been encountered because of improper mating of the lightweight headset connector to the suit harness and/or the T-adapter.

The most probable cause of the commander's loss of communication was either a loose airlock sleeve on one of three connectors, or an improper mating of the lightweight headset connector to the suit harness and T-adapter.

Figure 17-34.- Sectional view of airlock sleeve on connector shell.

For Apollo 10 and subsequent, the airlock sleeves will be torqued to between 45 and 50 inch-pounds and loctite will be applied to secure the sleeves to the connector.
